4. TITLE (and Subtitle) The deep sea moorings fishbite problem		5. TYPE OF REPORT & PERIOD COVERED Technical
7. AUTHOR(s) H.O. Berteaux, Dr. Bryce Prindle & Lt. Daniel May		6. PERFORMING ORG. REPORT NUMBER WHOI Contr. 6494

The Deep Sea Moorings Fishbite Problem\*

H.O. Berteaux<sup>1</sup>, Dr. Bryce Prindle<sup>1</sup>, and Lt. Daniel May<sup>2</sup>

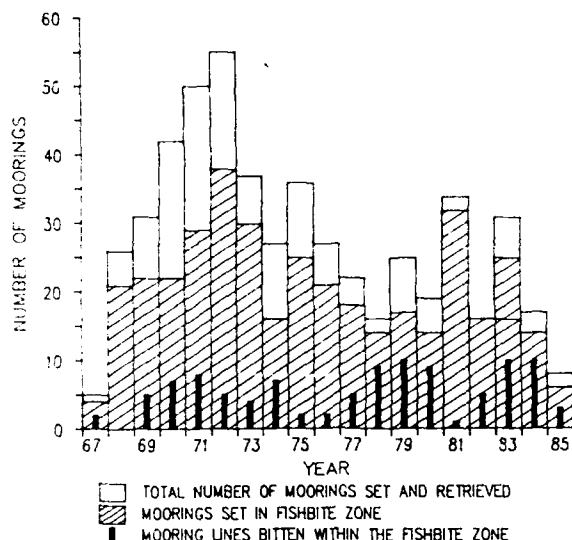
Figure 5. Yearly distribution of fishbites from WHOI mooring station logs (1967-1985).

A summary of yearly fishbite incidence is shown in Figure 5. Over this period biting appears to have been a significant hazard as 28% of the mooring lines set in the Fishbite Zone were reported found with typical fishbite markings.

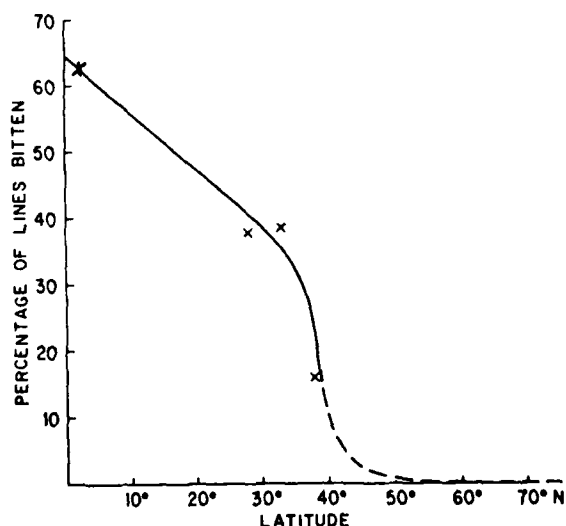
Figure 6. Percentage of lines bitten vs. latitude.

One may well ask whether risk of fishbite was found to be uniform throughout the Fishbite Zone. The data indicated that the risk rose as stations were established closer to the equator, as shown graphically in Figure 6. Somewhere within 10 degrees of the equator about 2/3 of all mooring lines were bitten. As latitude increased, the percentage fell off until the risk of biting became very small beyond 40°N.

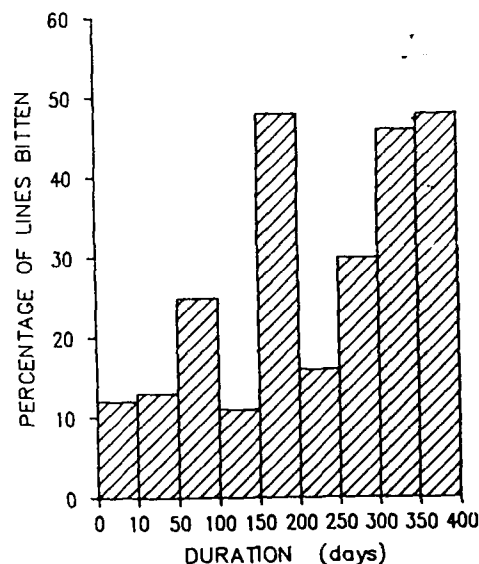
Figure 7. Percentage of lines bitten vs. duration.

One might surmise that the time a mooring line is in the water should have some correlation with the probability that it will be bitten. The record of bites vs. duration is shown graphically in Figure 7. Considerable variation is evident from one time interval to another. Overall, an upward trend in percentage of lines bitten seems indicated but fluctuations are so large that any closer analysis is difficult.

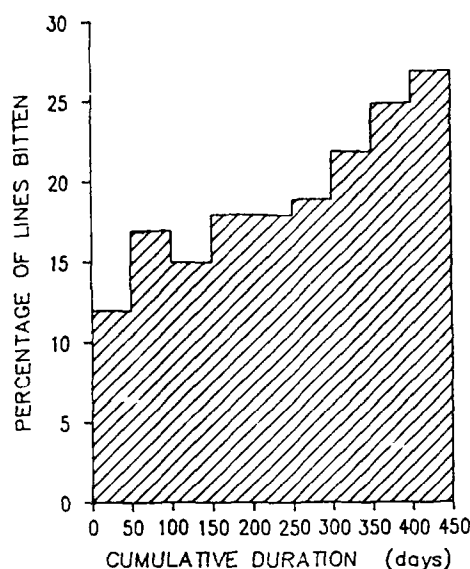
Figure 8. Percentage of lines bitten vs. cumulative duration.

Another approach to the problem is to treat the data in such a way that in effect, short duration times are regarded as part of longer duration times (Figure 8). In this approach not all possible environmental conditions are represented but the impact of conditions during any one time interval is lessened and, of course, as time intervals become larger and more moorings are deployed a limit is reached where all environmental factors are considered. Time then becomes the dominant variable.

Based on these data a biting rate of about 3% per 100 days is indicated. It is reasonable to expect that on an average, one mooring out of four would be attacked if set within the Fishbite Zone for a period of up to 450 days.

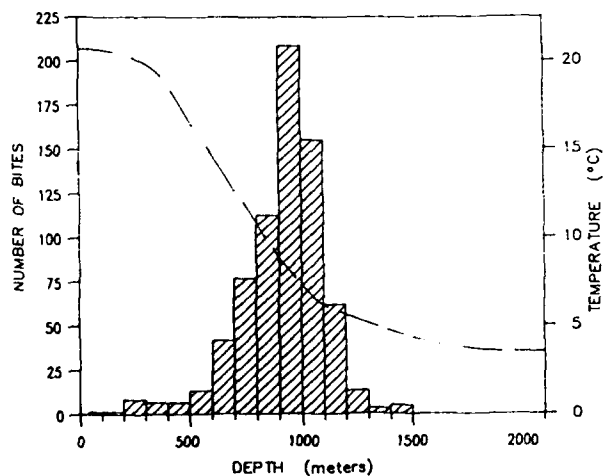
Figure 9. Frequency of bites vs. depth (Bermuda) (23).

8.13 mm. The coating took excellent dental impressions and retained a few fragments of teeth. The recovered line was run through a metering device and records were made of the depths at which evidence of biting was found. The frequency of bites as a function of depth thus obtained is plotted in Figure 9, together with the mean water temperature.

As can be seen, the major fraction of the bites occurred between 600 and 1200 meters with the peak of activity between 900 and 1000 meters. This indicates that the population of biters was concentrated near the bottom of the permanent thermocline. A detailed study of two moorings set further north produced the bite histograms shown in Figure 10 (26).

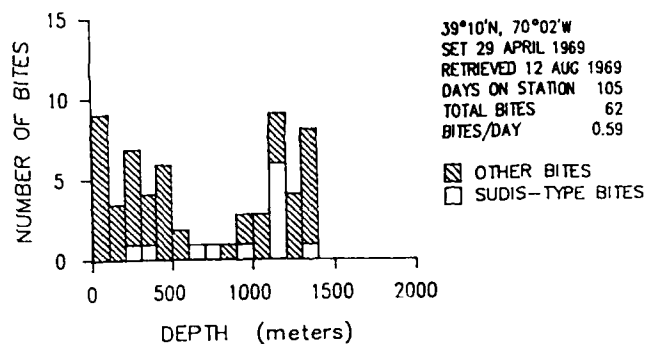
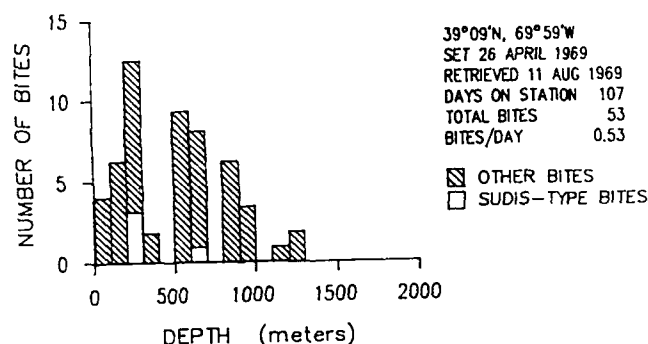
Figure 10. Number of bites vs. depth (Stations #298 and #300).

The total number of cuts in these moorings was 115, much less than in the previous (Bermuda) case. In terms of bites per day of exposure, a less concerted attack was noted. In addition, most of the bites were closer to the surface. A different species of biter seems indicated. The frequency of fishbite occurrence as a function of depth for all moorings set in the Fishbite Zone over the period considered in the report is presented in Figure 11.

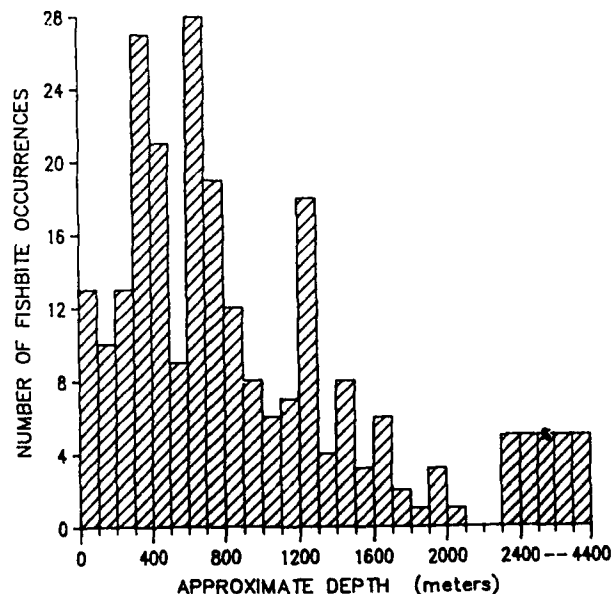
Figure 11. Number of fishbites vs. depth (Worldwide).

The data shows that 91% of the bites occurred at depths shallower than 1500 meters and 97% at depths shallower than 2000 meters. Moreover, it may well be that the few bites recorded as great depth bites in fact occurred during launch or recovery. The great majority of fishbite incidence was between the surface and 1000 meters depth.

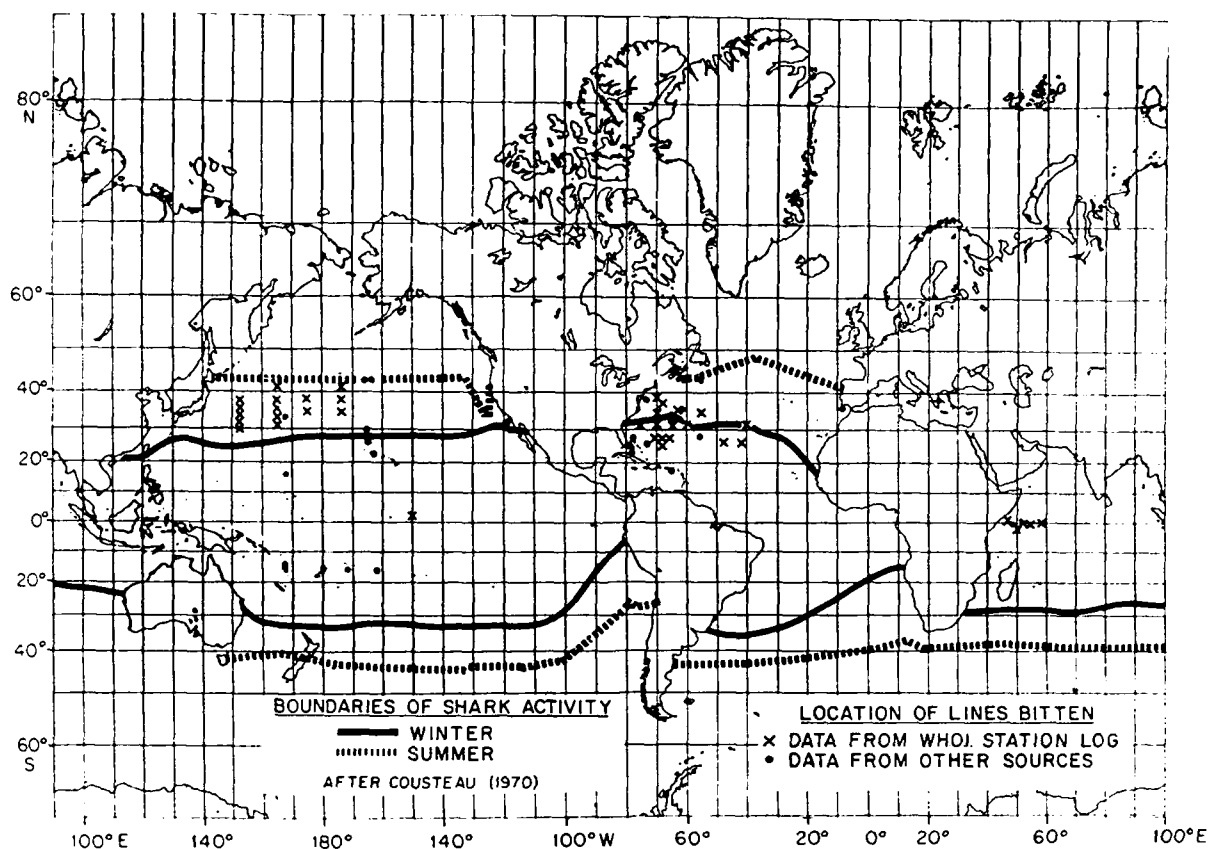
Figure 12. World geographic distribution of fishbite incidence.

When the information on all sources which have reported fishbite attacks to WHOI is plotted on a world chart, the geographic distribution of fishbite incidence is as shown in Figure 12. This chart seems to corroborate the relation between fishbite and warm surface water. However, it must be noted that more data should be acquired to properly represent all of the world oceans.
